**Flood Control Project Maintenance
Levee Inspections**

Fall 2012 Levee Maintenance Deficiency Summary Report

San Joaquin River Basin

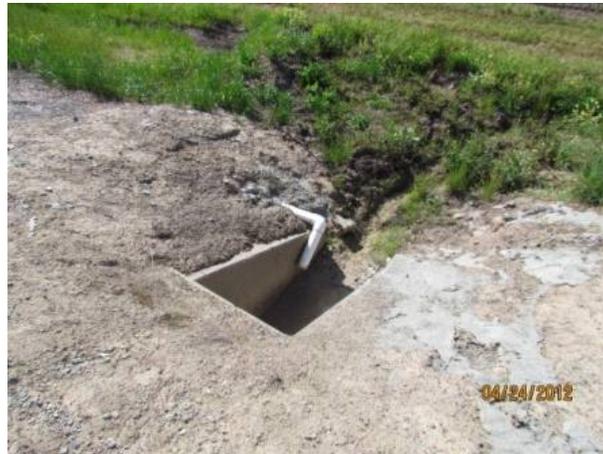
pkazi_f_20120913_142.jpg

Levee Mile Report Line	130
Start Levee Mile	12.05
End Levee Mile	12.05
Location	Land Side
Category	Earthen Levee
Item	Encroachments

A PVC pipe was found on the landside slope of the levee connecting to a culvert. The picture was taken from the crown looking upstream.

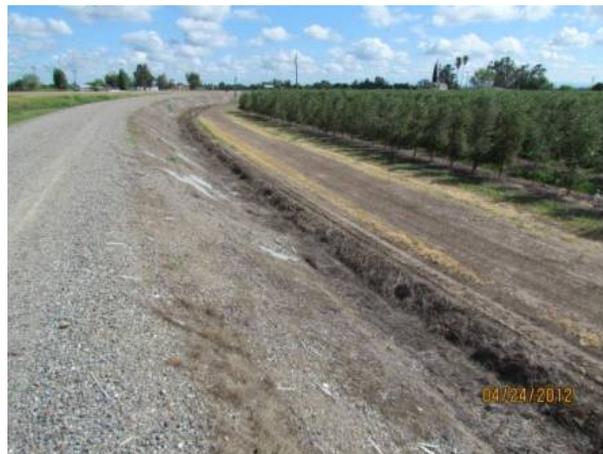
pkazi_f_20120913_143.jpg

Levee Mile Report Line	131
Start Levee Mile	12.49
End Levee Mile	12.49
Location	Land Side
Category	Earthen Levee
Item	Encroachments

An agricultural ditch was found on the landside toe of the levee looking upstream.

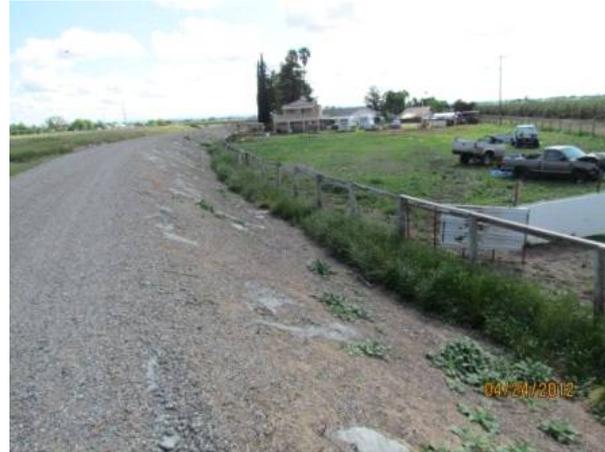
Levee Mile Report Line	132
Start Levee Mile	12.60
End Levee Mile	12.74
Location	Land Side
Category	Earthen Levee
Item	Encroachments
Fence was found on the landside of the levee looking upstream.	
pkazi_f_20120913_141.jpg

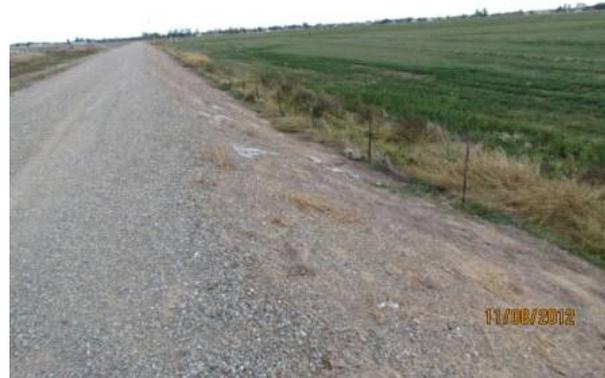
Levee Mile Report Line	133
Start Levee Mile	12.77
End Levee Mile	13.06
Location	Land Side
Category	Earthen Levee
Item	Encroachments
Fence was located on the landside toe of the levee looking upstream.	
pkazi_f_20121109_031.jpg

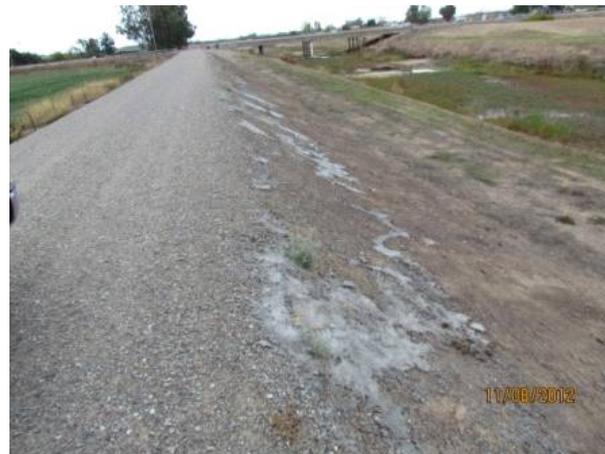
Levee Mile Report Line	134
Start Levee Mile	12.83
End Levee Mile	12.83
Location	Water Side
Category	Earthen Levee
Item	Animal Control
Animal holes were grouted by the LMA on the waterside slope of the levee looking downstream.	
pkazi_f_20121109_032.jpg

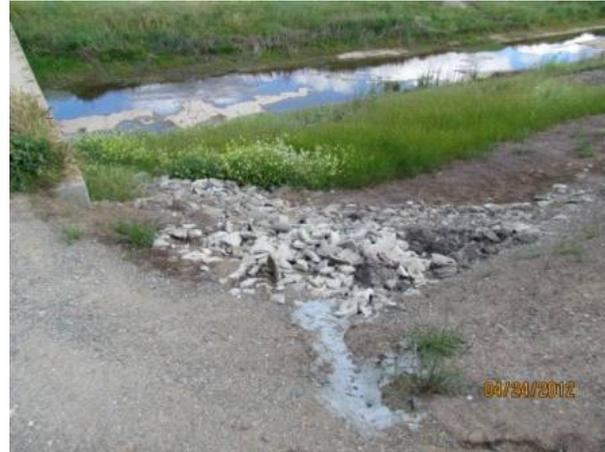
Levee Mile Report Line	136
Start Levee Mile	12.98
End Levee Mile	12.98
Location	Water Side
Category	Earthen Levee
Item	Encroachments
Debris was found on the waterside of the levee looking upstream.	
pkazi_f_20120913_144.jpg

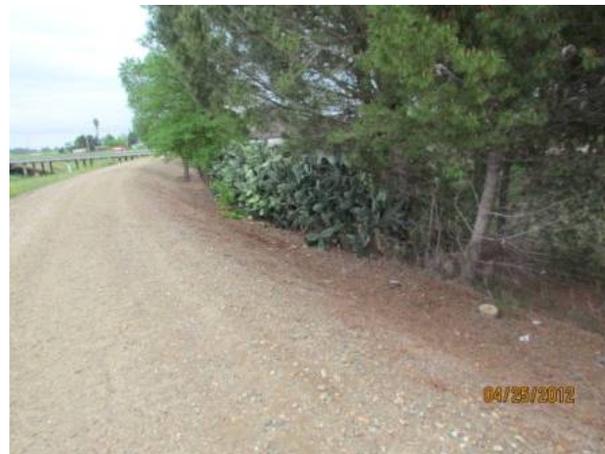
Levee Mile Report Line	139
Start Levee Mile	13.54
End Levee Mile	13.54
Location	Land Side
Category	Earthen Levee
Item	Vegetation
Cacti was found on the landside of the levee looking upstream.	
pkazi_f_20120913_146.jpg

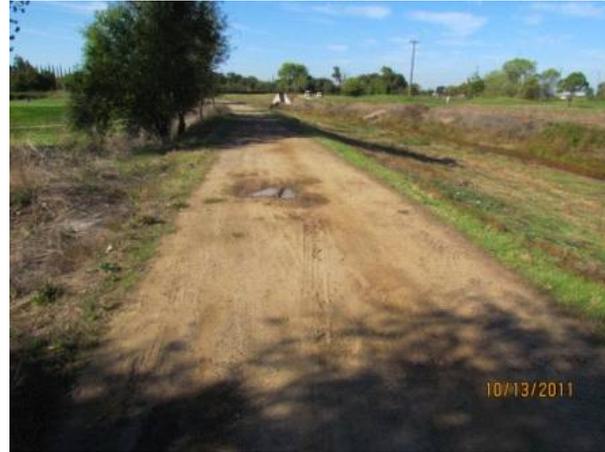
Levee Mile Report Line	150
Start Levee Mile	15.44
End Levee Mile	15.44
Location	Crown
Category	Earthen Levee
Item	Crown Surface / Depressions / Rutting
Depression was found on the crown of the levee looking downstream.	
pkazi_f_20120913_157.jpg

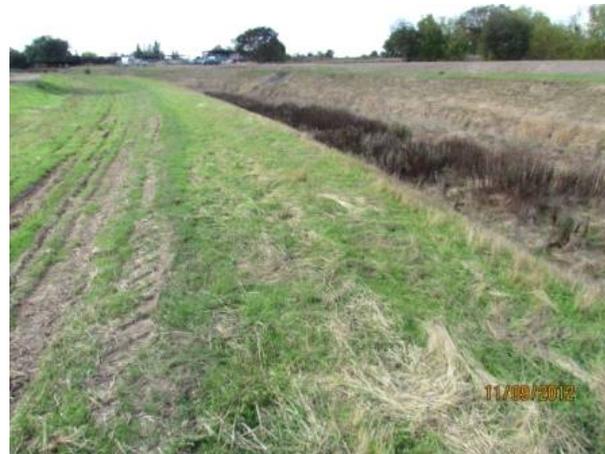
Levee Mile Report Line	155
Start Levee Mile	16.00
End Levee Mile	16.00
Location	Water Side
Category	Earthen Levee
Item	Erosion / Bank Caving
Erosion was repaired by the LMA on the waterside shoulder of the levee looking downstream.	
pkazi_f_20121109_048.jpg

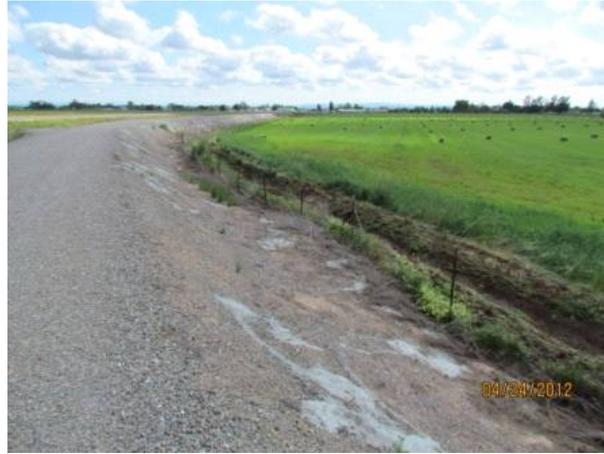
Levee Mile Report Line	1
Start Levee Mile	0.02
End Levee Mile	0.55
Location	Land Side
Category	Earthen Levee
Item	Encroachments
Fences were found on the landside toe of the levee looking upstream.	
pkazi_f_20120913_223.jpg

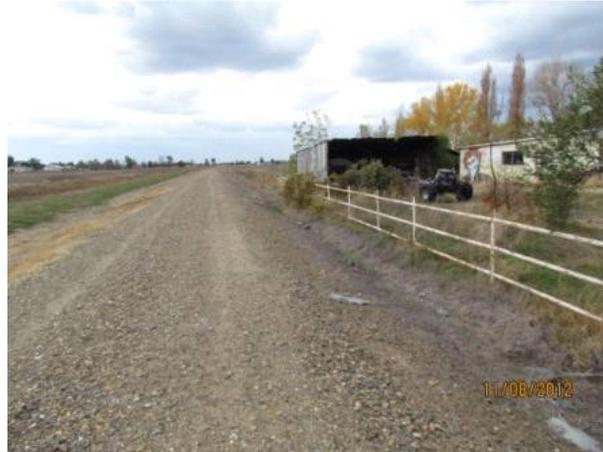
Levee Mile Report Line	1
Start Levee Mile	0.35
End Levee Mile	1.32
Location	Land Side
Category	Earthen Levee
Item	Encroachments
Fence was found on the landside toe of the levee looking downstream.	
pkazi_f_20121109_034.jpg

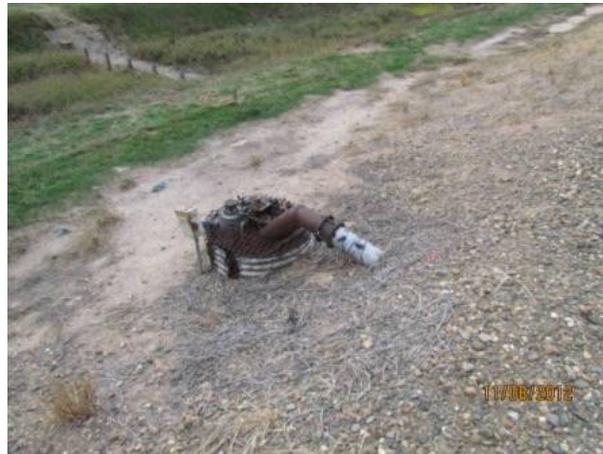
Levee Mile Report Line	2
Start Levee Mile	0.42
End Levee Mile	0.42
Location	Water Side
Category	Earthen Levee
Item	Encroachments
Pipe penetration was found under the crown of the levee looking downstream.	
pkazi_f_20121109_035.jpg

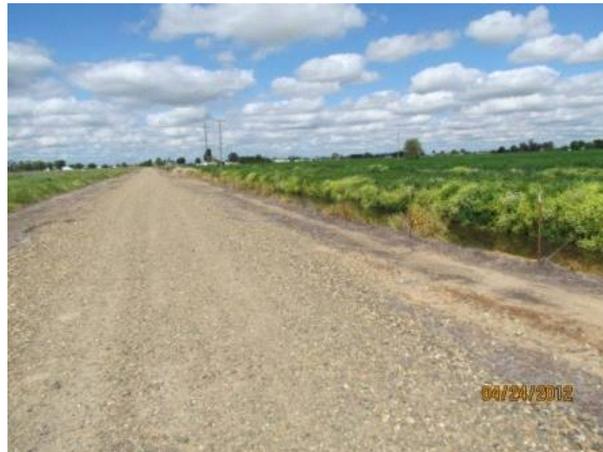
Levee Mile Report Line	3
Start Levee Mile	0.46
End Levee Mile	0.92
Location	Land Side
Category	Earthen Levee
Item	Encroachments
Fences were found on the landside of the levee looking downstream.	
pkazi_f_20120913_226.jpg

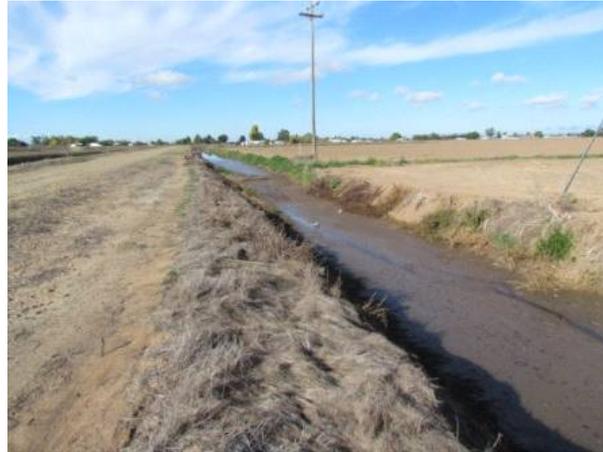
pkazi_f_20120913_231.jpg

An agricultural ditch was found on the landside of the levee looking downstream.

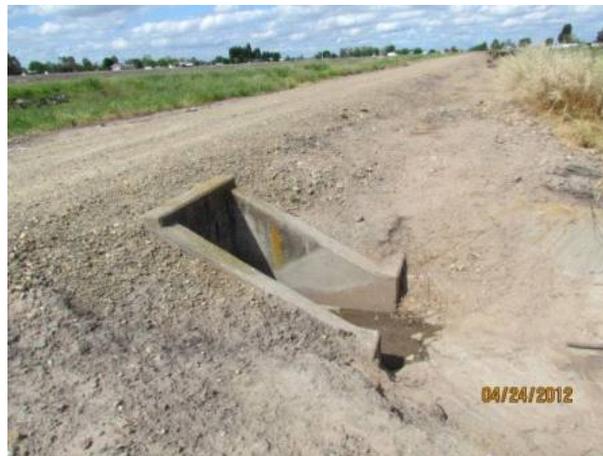
pkazi_f_20120913_227.jpg

Levee Mile Report Line	5
Start Levee Mile	0.87
End Levee Mile	0.87
Location	Water Side
Category	Interior Drainage & Piping Systems
Item	Culverts: Inlets / Outlets

Culvert inlet was cleaned out by the LMA on the landside of the levee looking downstream.

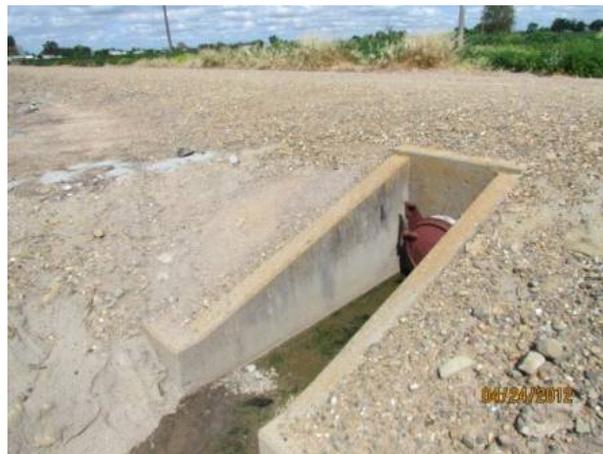
pkazi_f_20120913_228.jpg

Levee Mile Report Line	5
Start Levee Mile	0.87
End Levee Mile	0.87
Location	Water Side
Category	Interior Drainage & Piping Systems
Item	Culverts: Inlets / Outlets

Culvert outlet was cleaned out by the LMA on the waterside of the levee looking downstream.

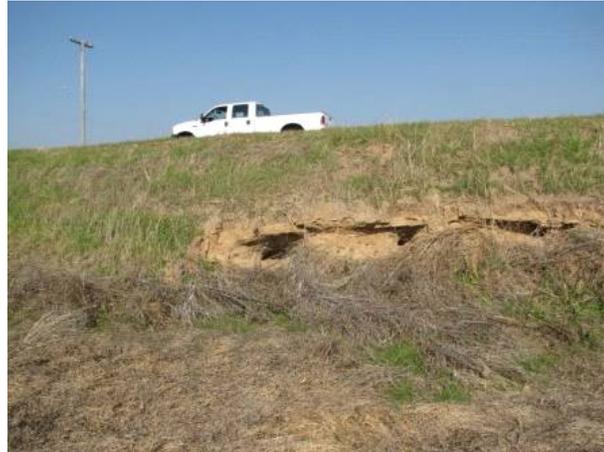
pkazi_f_20120913_229.jpg

View of rodent holes in the waterward berm from the channel.

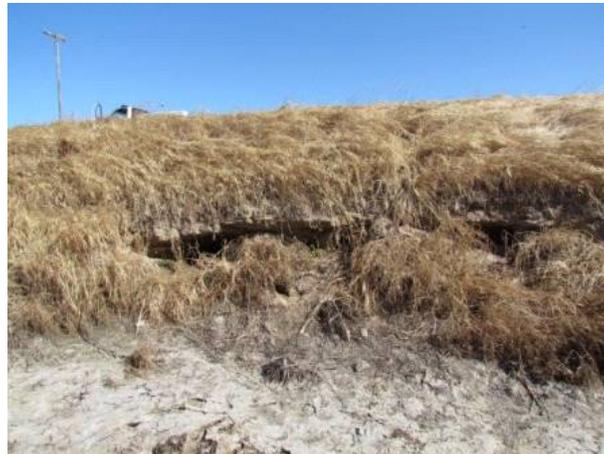
pkazi_f_20120913_230.jpg

Levee Mile Report Line	6
Start Levee Mile	0.87
End Levee Mile	0.87
Location	Water Side
Category	Earthen Levee
Item	Animal Control

Erosion above the pilot channel was located but it didn't look like rodent holes. The picture was taken from the toe at the waterside of the levee looking towards the crown.

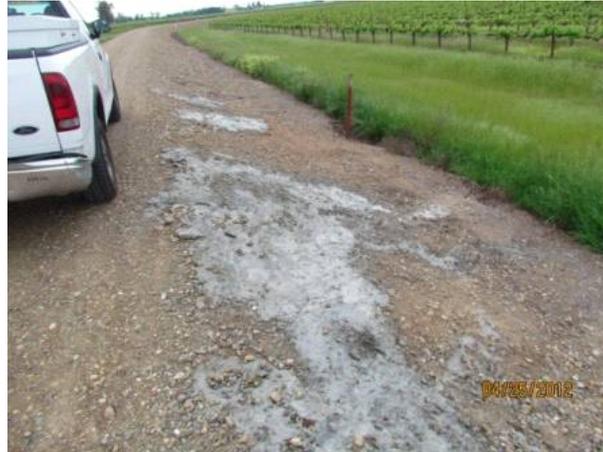
Levee Mile Report Line	1
Start Levee Mile	0.11
End Levee Mile	0.11
Location	Land Side
Category	Earthen Levee
Item	Animal Control
<p>Animal holes were grouted by the LMA on the landside of the levee looking downstream.</p>	
<p>pkazi_f_20120913_239.jpg</p>

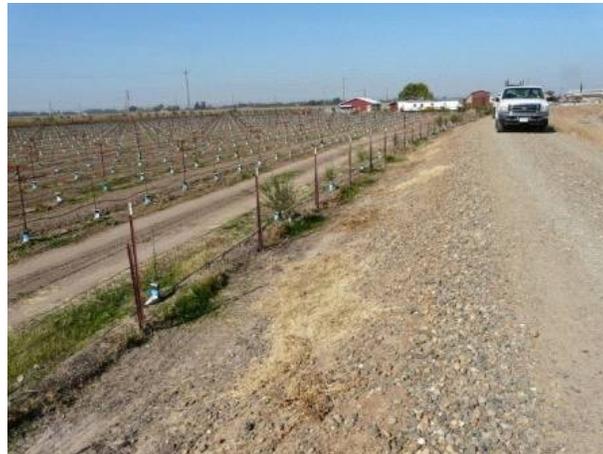
Levee Mile Report Line	2
Start Levee Mile	0.17
End Levee Mile	0.49
Location	Land Side
Category	Earthen Levee
Item	Encroachments
<p>Fence located from LM 0.17 to LM 0.49 and crops located from LM 0.17 to LM 0.41 within 10' from landside toe of levee.</p>	
<p>pkazi_f_20120913_232.JPG</p>

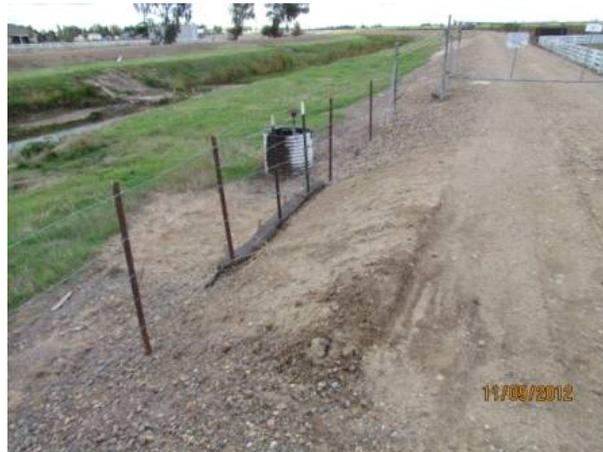
Levee Mile Report Line	6
Start Levee Mile	0.48
End Levee Mile	0.48
Location	Water Side
Category	Earthen Levee
Item	Slope Stability
<p>LMA has repaired the slope instability issue on the waterside slope of the levee looking downstream.</p>	
<p>pkazi_f_20121109_046.jpg</p>

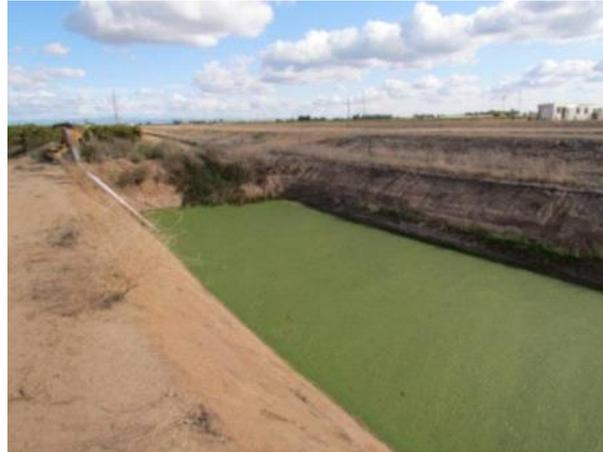
Levee Mile Report Line	8
Start Levee Mile	1.07
End Levee Mile	1.14
Location	Land Side
Category	Earthen Levee
Item	Encroachments
View of the ditch on the landside of the levee looking upstream. The picture was taken during fall 2011 inspection.	
pkazi_f_20120913_242.jpg

REQUESTED CORRECTION: Repair the ditch at the landside toe of the levee. The ditch is approximately 10 feet in width from the toe of the levee. likely to cause significant levee stability issue.

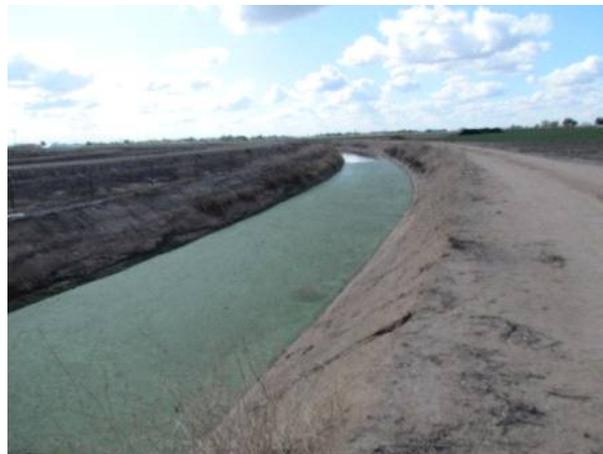
Levee Mile Report Line	8
Start Levee Mile	1.07
End Levee Mile	1.14
Location	Land Side
Category	Earthen Levee
Item	Encroachments
This notice of violation was given to the property owner who constructed the ditch.	
pkazi_f_20120913_244.jpg

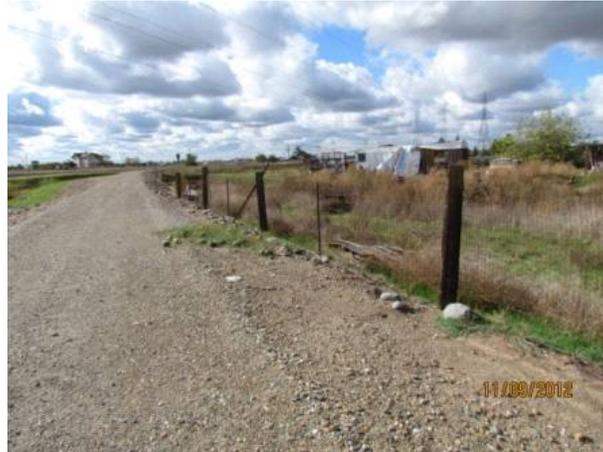
Levee Mile Report Line	12
Start Levee Mile	2.25
End Levee Mile	2.42
Location	Land Side
Category	Earthen Levee
Item	Encroachments
A fence was found on the landside toe of the levee looking downstream.	
pkazi_f_20121109_045.jpg

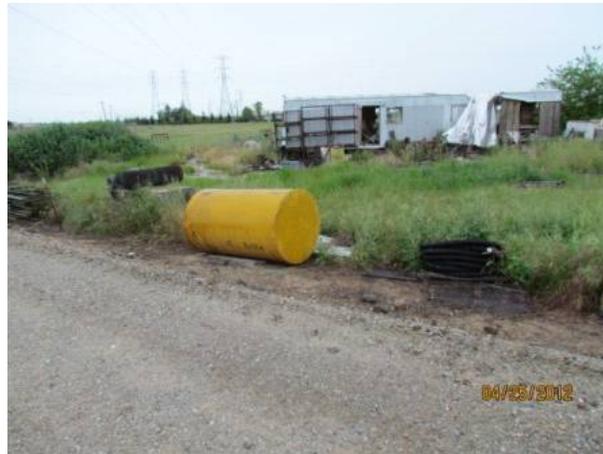
Levee Mile Report Line	13
Start Levee Mile	2.40
End Levee Mile	2.40
Location	Land Side
Category	Earthen Levee
Item	Encroachments
A tank and debris was found on the landside of the levee looking downstream.	
pkazi_f_20120913_235.jpg

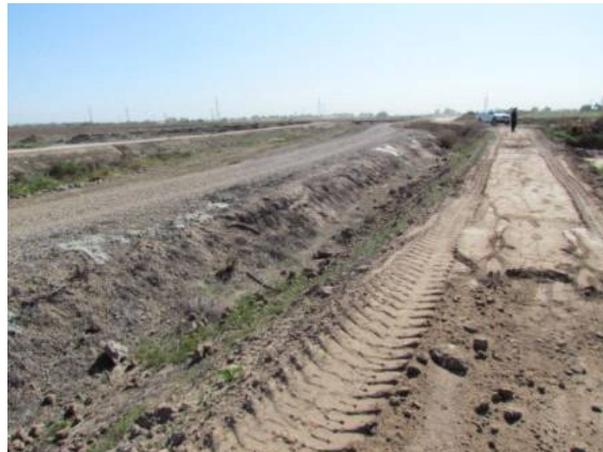
Levee Mile Report Line	14
Start Levee Mile	2.90
End Levee Mile	3.14
Location	Land Side
Category	Earthen Levee
Item	Encroachments
A ditch was found on the landside of the levee looking downstream.	
pkazi_f_20120913_233.jpg

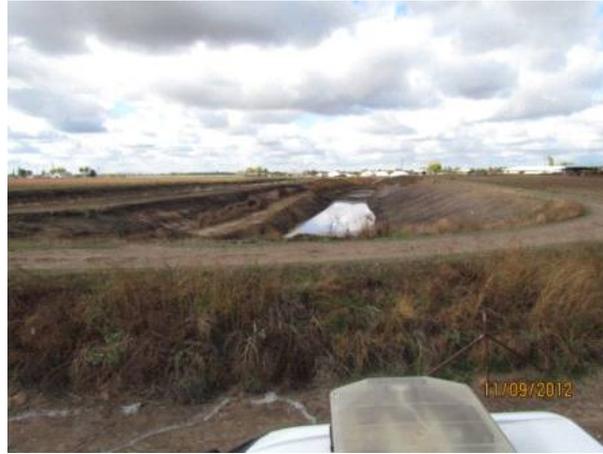
Levee Mile Report Line	15
Start Levee Mile	2.97
End Levee Mile	2.97
Location	Land Side
Category	Earthen Levee
Item	Encroachments
<p>A detention pond was found next the landside toe of the levee. The pond had approximately depth of 15 feet. The picture was taken from the crown looking towards the toe of the levee.</p>	
<p>pkazi_f_20121109_044.jpg</p>

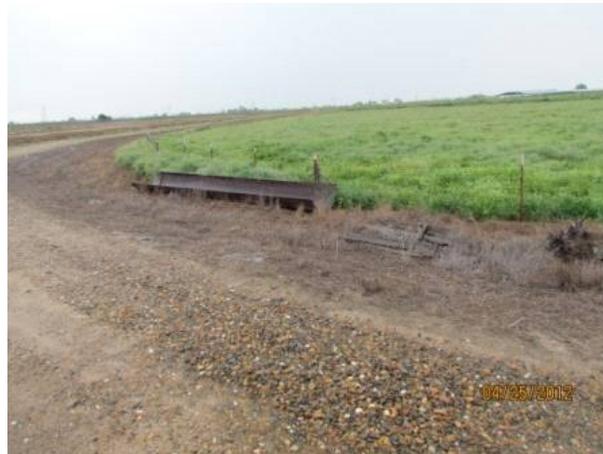
Levee Mile Report Line	17
Start Levee Mile	3.38
End Levee Mile	3.38
Location	Land Side
Category	Earthen Levee
Item	Encroachments
<p>Debris was found on the landside of the levee looking downstream.</p>	
<p>pkazi_f_20120913_234.jpg</p>

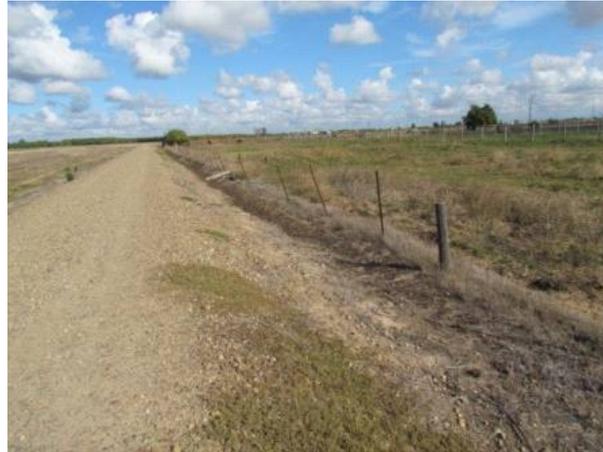
Levee Mile Report Line	2
Start Levee Mile	0.78
End Levee Mile	1.30
Location	Land Side
Category	Earthen Levee
Item	Encroachments
Fence was located on the landside toe of the levee looking upstream.	
pkazi_f_20120913_245.jpg

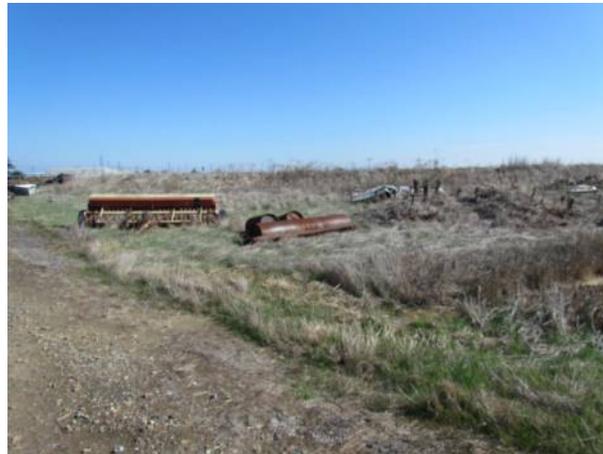
Levee Mile Report Line	5
Start Levee Mile	1.81
End Levee Mile	1.81
Location	Land Side
Category	Earthen Levee
Item	Encroachments
Equipment was found on the landside of the levee looking upstream.	
pkazi_f_20120913_259.jpg

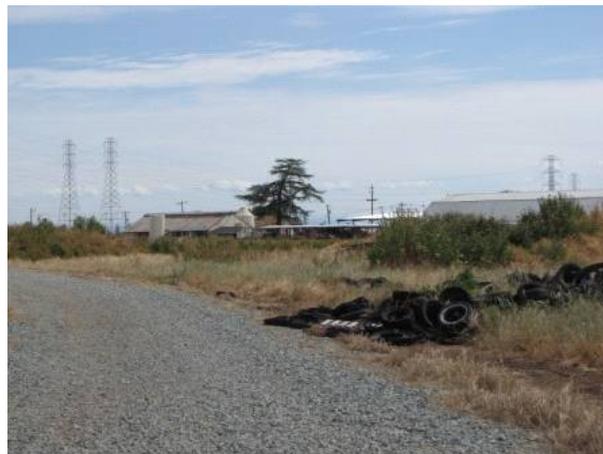
Levee Mile Report Line	6
Start Levee Mile	1.85
End Levee Mile	1.85
Location	Land Side
Category	Earthen Levee
Item	Encroachments
View of tires on the landward portion of the levee looking upstream.	
pkazi_f_20120913_258.jpg

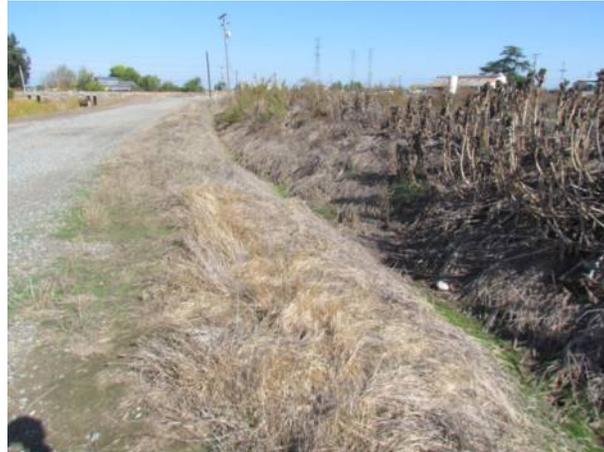
Levee Mile Report Line	7
Start Levee Mile	1.91
End Levee Mile	1.91
Location	Land Side
Category	Earthen Levee
Item	Encroachments
<p>A ditch was located on the landside toe of the levee looking upstream.</p>	
<p>pkazi_f_20120913_260.jpg</p>

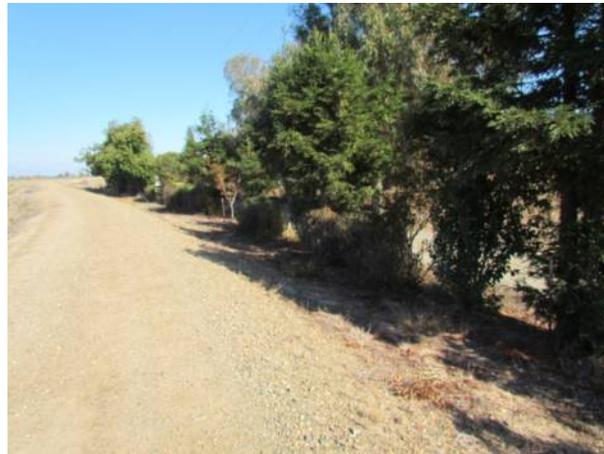
Levee Mile Report Line	11
Start Levee Mile	2.37
End Levee Mile	2.43
Location	Land Side
Category	Earthen Levee
Item	Vegetation
<p>Trees and landscaping was found on the landside of the levee looking upstream.</p>	
<p>pkazi_f_20120913_249.jpg</p>

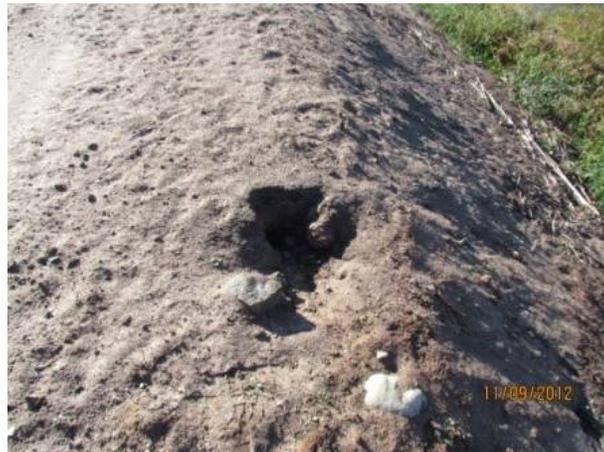
Levee Mile Report Line	13
Start Levee Mile	2.79
End Levee Mile	2.79
Location	Water Side
Category	Earthen Levee
Item	Animal Control
<p>An animal hole was found on the waterside shoulder of the levee looking downstream.</p>	
<p>pkazi_f_20121109_040.jpg</p>

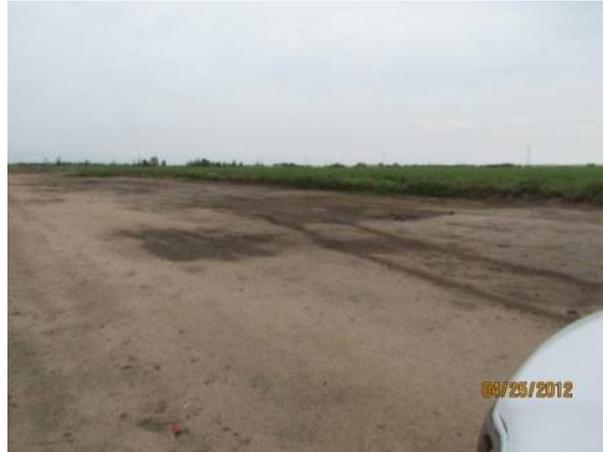
Levee Mile Report Line	14
Start Levee Mile	2.88
End Levee Mile	2.88
Location	Crown
Category	Earthen Levee
Item	Crown Surface / Depressions / Rutting
Depression was found on the crown of the levee looking upstream.	
pkazi_f_20120913_250.jpg

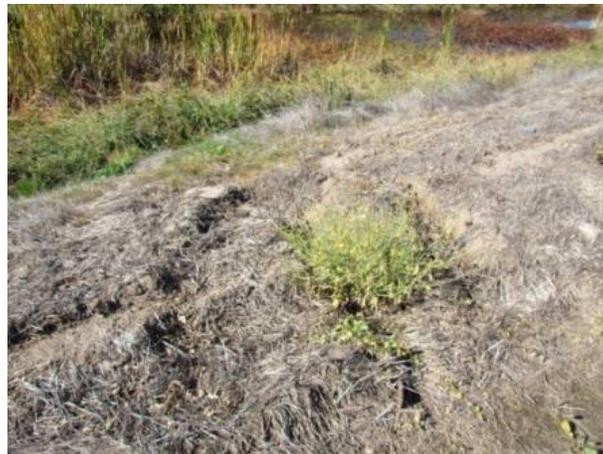
Levee Mile Report Line	15
Start Levee Mile	2.93
End Levee Mile	2.93
Location	Water Side
Category	Earthen Levee
Item	Slope Stability
Slope instability was found on the waterside of the levee looking upstream.	
pkazi_f_20120913_263.jpg

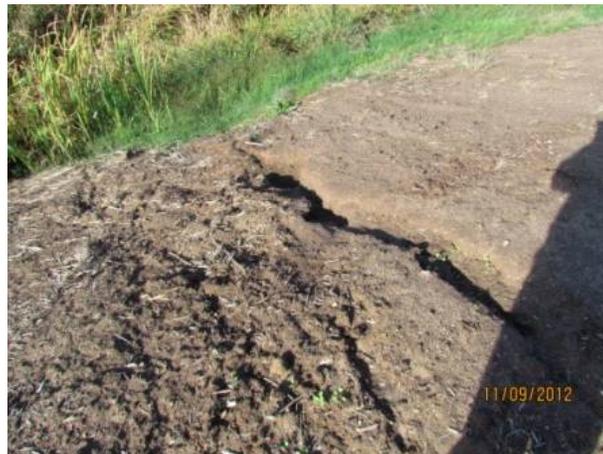
Levee Mile Report Line	15
Start Levee Mile	2.93
End Levee Mile	2.93
Location	Water Side
Category	Earthen Levee
Item	Slope Stability
Slope instability possible caused by excessive runoff at the waterside shoulder of the levee looking upstream.	
pkazi_f_20121109_041.jpg

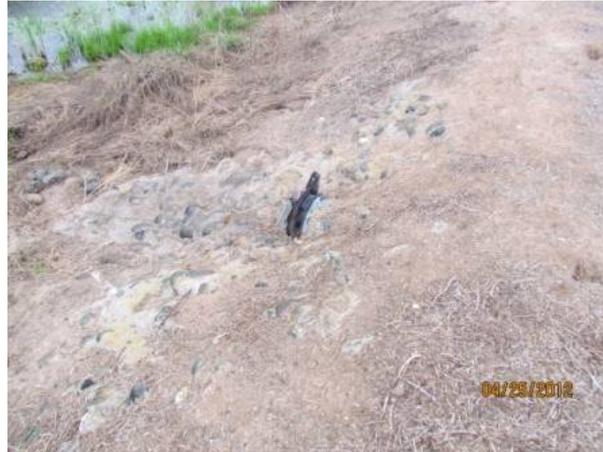
Levee Mile Report Line	16
Start Levee Mile	2.95
End Levee Mile	2.95
Location	Water Side
Category	Interior Drainage & Piping Systems
Item	Flap Gates
<p>Flap gate was fixed by the LMA on the waterside of the levee looking upstream.</p>	
<p>pkazi_f_20120913_252.jpg</p>

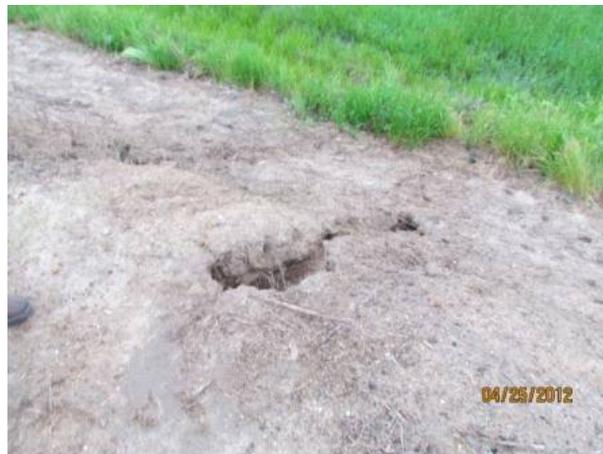
Levee Mile Report Line	17
Start Levee Mile	3.16
End Levee Mile	3.16
Location	Water Side
Category	Earthen Levee
Item	Erosion / Bank Caving
<p>Erosion was found on the waterside of the levee looking downstream.</p>	
<p>pkazi_f_20120913_253.jpg</p>

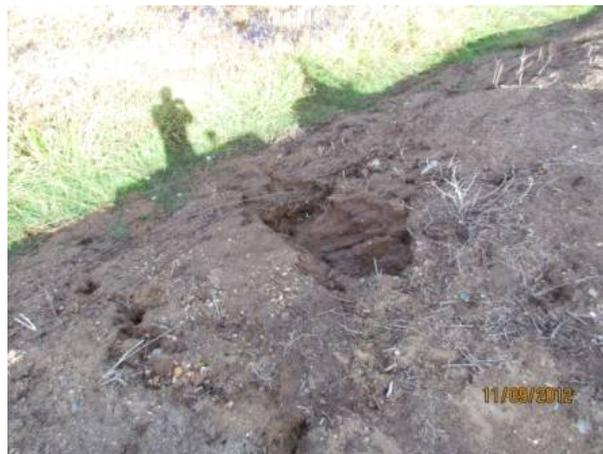
Levee Mile Report Line	19
Start Levee Mile	3.28
End Levee Mile	3.28
Location	Water Side
Category	Earthen Levee
Item	Slope Stability
<p>Slope instability was found on the waterside slope of the levee looking upstream.</p>	
<p>pkazi_f_20121109_042.jpg</p>

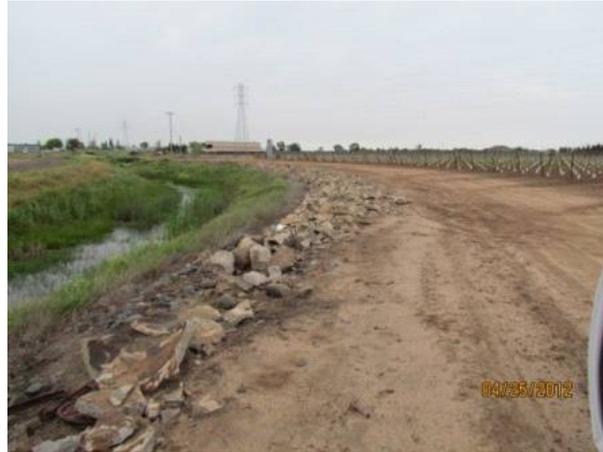
Levee Mile Report Line	20
Start Levee Mile	3.29
End Levee Mile	3.34
Location	Water Side
Category	Earthen Levee
Item	Encroachments
Debris was found on the waterside of the levee looking upstream.	
pkazi_f_20120913_254.jpg

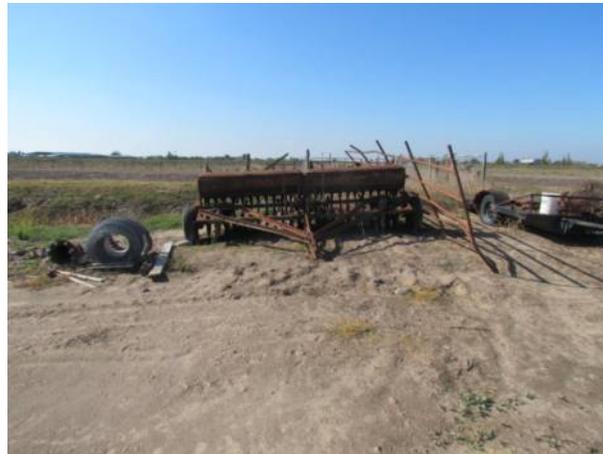
Levee Mile Report Line	21
Start Levee Mile	3.39
End Levee Mile	3.39
Location	Water Side
Category	Earthen Levee
Item	Encroachments
Farming equipment was found on the waterside of the levee looking upstream.	
pkazi_f_20120913_264.jpg

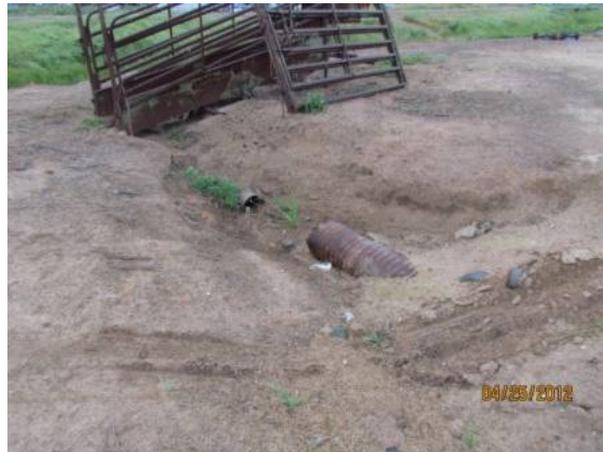
Levee Mile Report Line	23
Start Levee Mile	3.42
End Levee Mile	3.42
Location	Water Side
Category	Earthen Levee
Item	Encroachments
A broken culvert pipe was found on the crown of the levee. The picture was taken from the crown looking towards the toe of the levee.	
pkazi_f_20120913_256.jpg

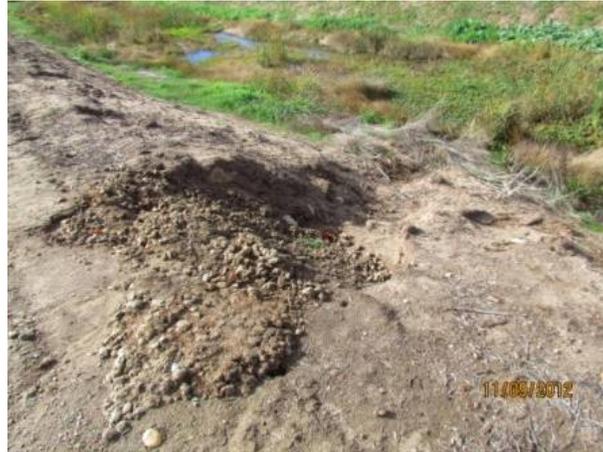
Levee Mile Report Line	24
Start Levee Mile	3.48
End Levee Mile	3.48
Location	Water Side
Category	Earthen Levee
Item	Erosion / Bank Caving
Erosion was found on the waterside slope of the levee looking downstream.	
pkazi_f_20121109_043.jpg

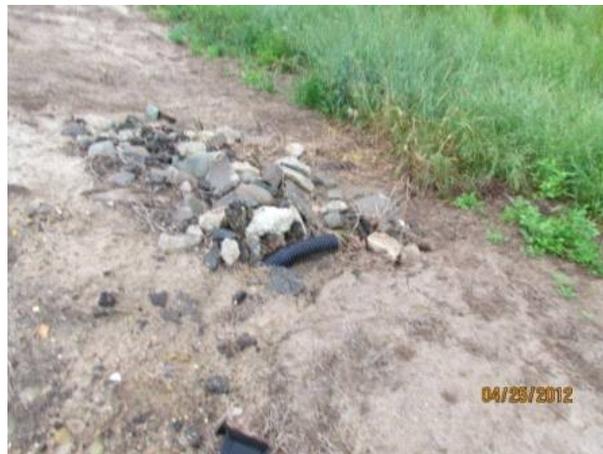
Levee Mile Report Line	25
Start Levee Mile	3.51
End Levee Mile	3.51
Location	Water Side
Category	Earthen Levee
Item	Encroachments
A active running pipe was found on the waterside of the levee looking downstream.	
pkazi_f_20120913_257.jpg

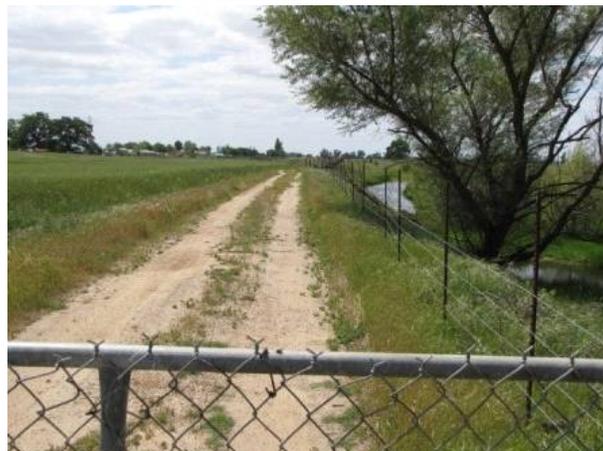
Levee Mile Report Line	26
Start Levee Mile	3.53
End Levee Mile	3.92
Location	Crown
Category	Earthen Levee
Item	Encroachments
Fence along waterward sholder and crown of access road. The road cannot be driven through as the fence blocks access. The gate does not have a county key on the gate.	
pkazi_f_20120913_251.jpg

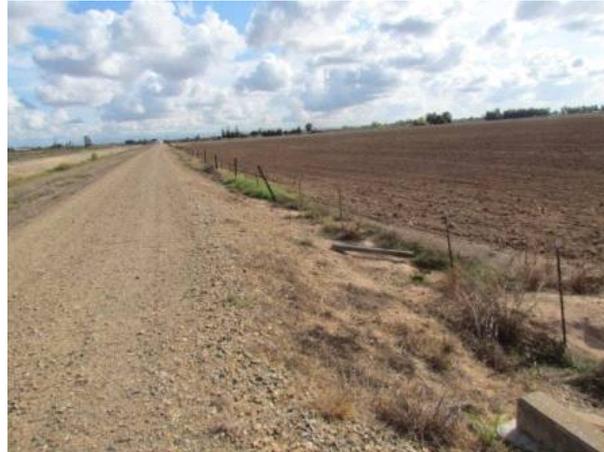
Levee Mile Report Line	1
Start Levee Mile	0.00
End Levee Mile	1.38
Location	Land Side
Category	Earthen Levee
Item	Encroachments
Fence was located on the landside of the levee looking upstream.	
pkazi_f_20120913_267.jpg

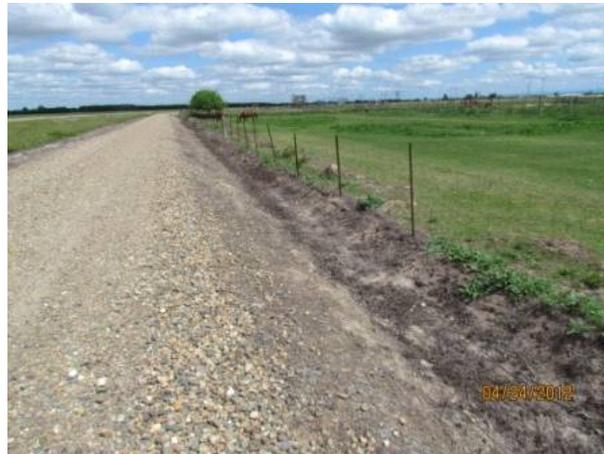
Levee Mile Report Line	1
Start Levee Mile	0.00
End Levee Mile	1.38
Location	Land Side
Category	Earthen Levee
Item	Encroachments
Fence was found on the landside of the levee looking upstream.	
pkazi_f_20120913_268.jpg

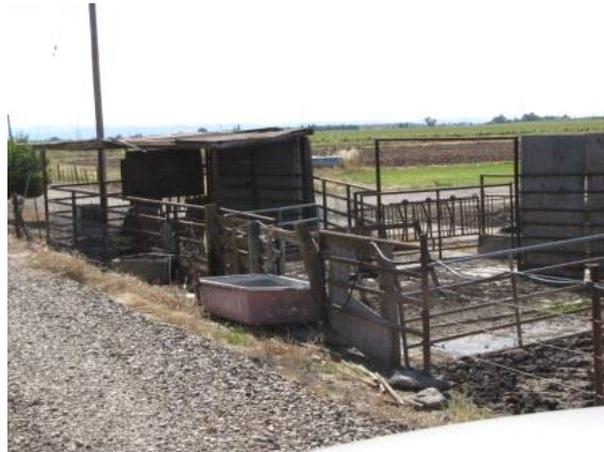
Levee Mile Report Line	2
Start Levee Mile	0.39
End Levee Mile	0.39
Location	Land Side
Category	Earthen Levee
Item	Encroachments
View of a tub/tank on the landward slope blocking access and visibility looking upstream.	
pkazi_f_20120913_266.jpg

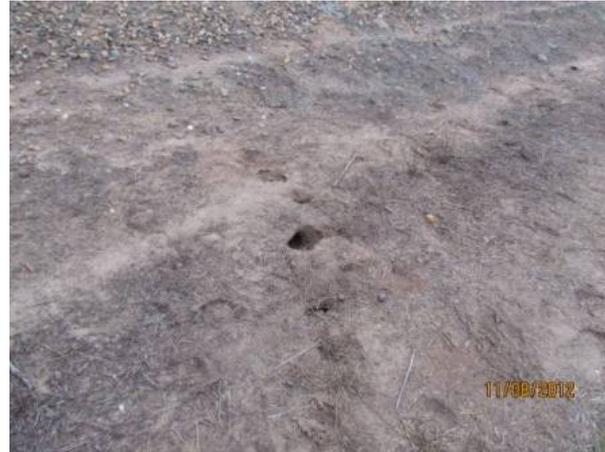
Levee Mile Report Line	5
Start Levee Mile	1.06
End Levee Mile	1.06
Location	Water Side
Category	Earthen Levee
Item	Animal Control
<p>Animal holes were found on the waterside slope of the levee looking downstream.</p>	
<p>pkazi_f_20121109_036.jpg</p>

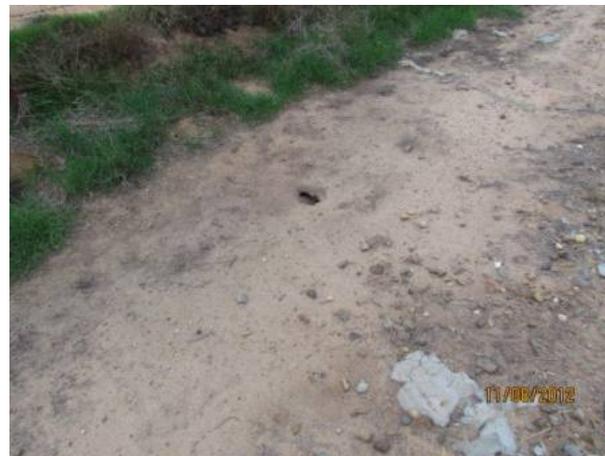
Levee Mile Report Line	7
Start Levee Mile	1.36
End Levee Mile	1.36
Location	Land Side
Category	Earthen Levee
Item	Animal Control
<p>An animal hole was found on the landside toe of the levee looking downstream.</p>	
<p>pkazi_f_20121109_037.jpg</p>

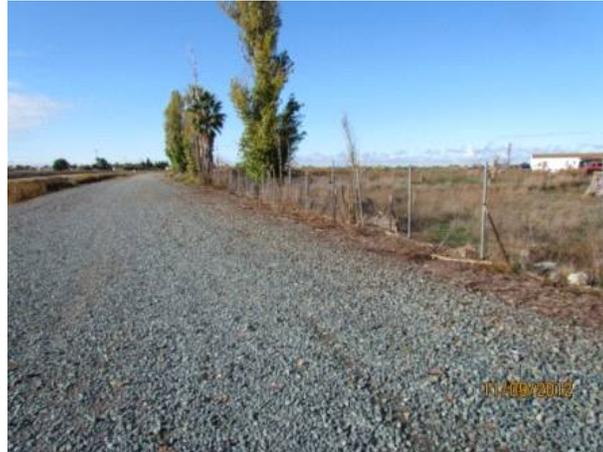
Levee Mile Report Line	1
Start Levee Mile	0.02
End Levee Mile	0.55
Location	Land Side
Category	Earthen Levee
Item	Encroachments
Fence was found on the landside of the levee looking downstream.	
pkazi_f_20121109_039.jpg

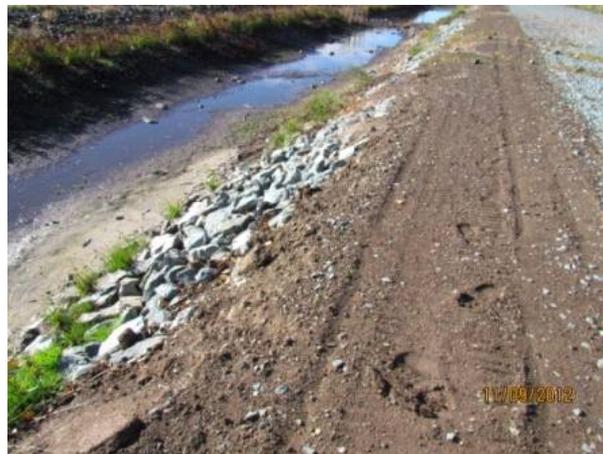
Levee Mile Report Line	3
Start Levee Mile	0.44
End Levee Mile	0.44
Location	Water Side
Category	Earthen Levee
Item	Erosion / Bank Caving
Erosion on the waterside shoulder was repaired by the LMA. The picture was taken from the crown looking downstream.	
pkazi_f_20121109_038.jpg

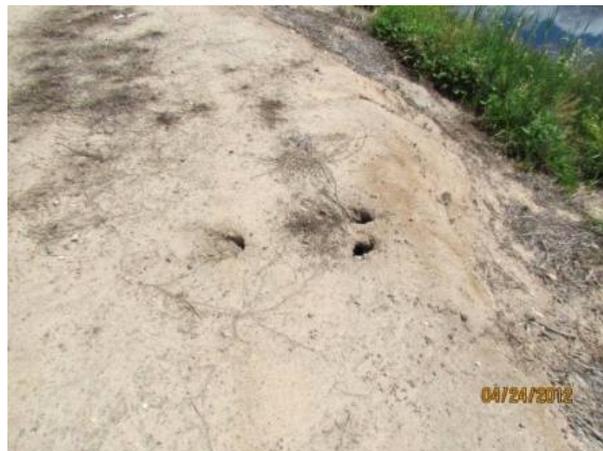
Levee Mile Report Line	5
Start Levee Mile	0.61
End Levee Mile	0.61
Location	Water Side
Category	Earthen Levee
Item	Animal Control
Animal holes were found on the waterside of the levee looking upstream.	
pkazi_f_20120913_277.jpg

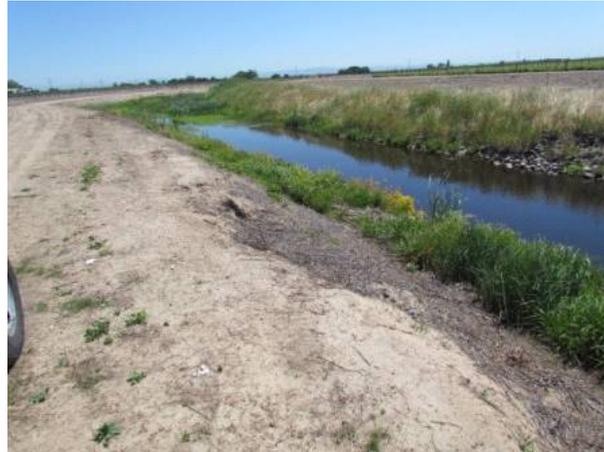
Levee Mile Report Line	6
Start Levee Mile	0.61
End Levee Mile	0.61
Location	Water Side
Category	Earthen Levee
Item	Erosion / Bank Caving
Erosion was found on the waterside of the levee.	
pkazi_f_20120913_275.jpg

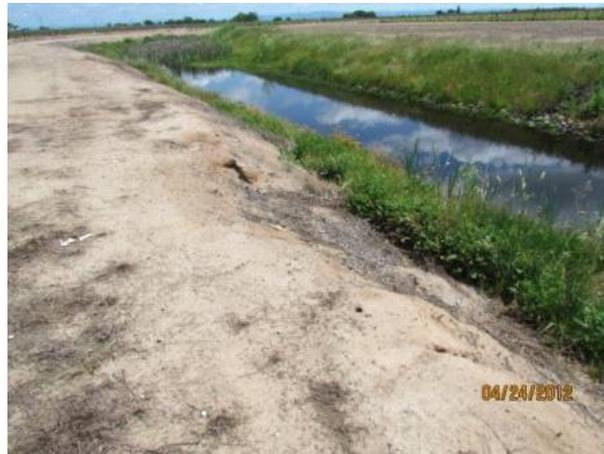
Levee Mile Report Line	6
Start Levee Mile	0.61
End Levee Mile	0.61
Location	Water Side
Category	Earthen Levee
Item	Erosion / Bank Caving
Erosion was found on the waterside of the levee looking upstream. This picture was taken during spring 2012 inspection.	
pkazi_f_20120913_276.jpg

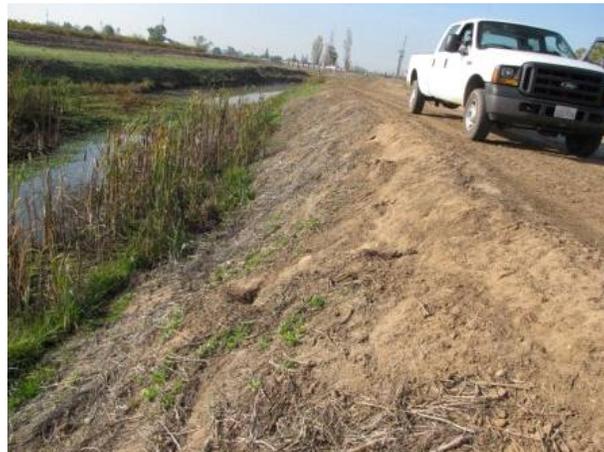
Levee Mile Report Line	7
Start Levee Mile	0.65
End Levee Mile	0.65
Location	Water Side
Category	Earthen Levee
Item	Animal Control
View of rodent holes in the waterward berm looking downstream.	
pkazi_f_20120913_272.jpg

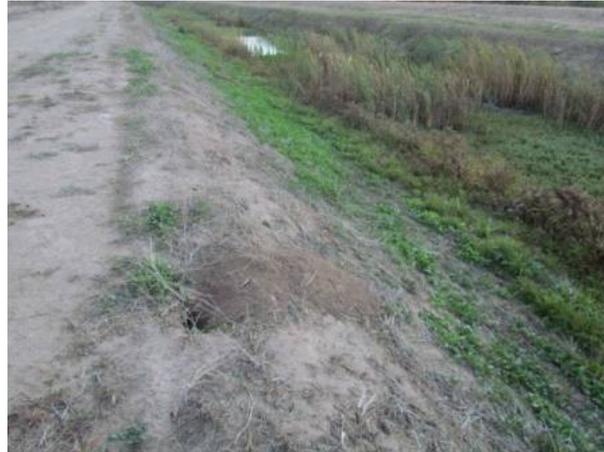
pkazi_f_20120913_274.jpg

Rodent hole was found on the waterside shoulder of the levee looking upstream.

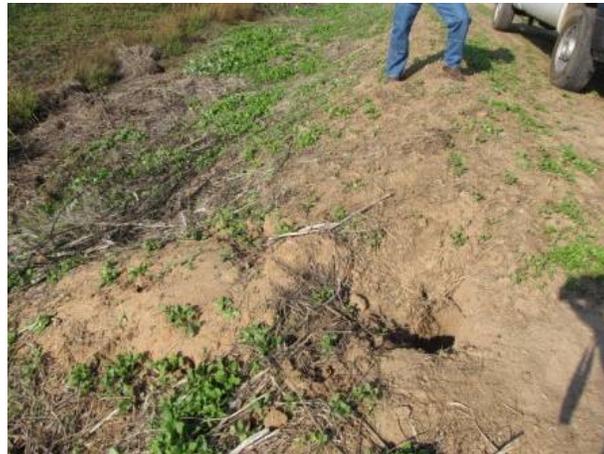
pkazi_f_20120913_273.jpg

Levee Mile Report Line	9
Start Levee Mile	0.83
End Levee Mile	0.83
Location	Water Side
Category	Earthen Levee
Item	Animal Control

View of a large diameter rodent hole in the waterward berm looking downstream.

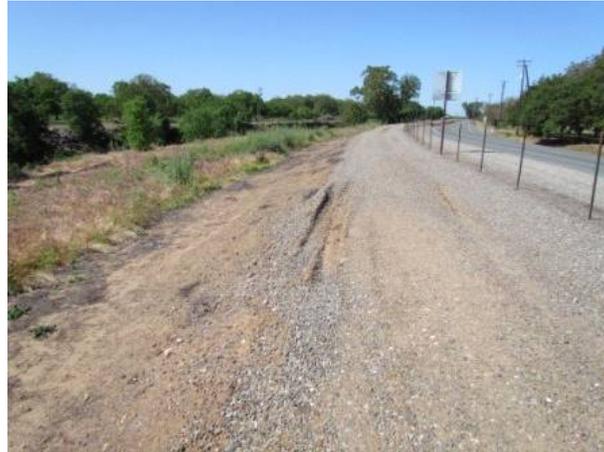
pkazi_f_20120913_294.jpg

Rutting and depression was found on the shoulder of landside of the levee. The picture was taken from the crown looking downstream.

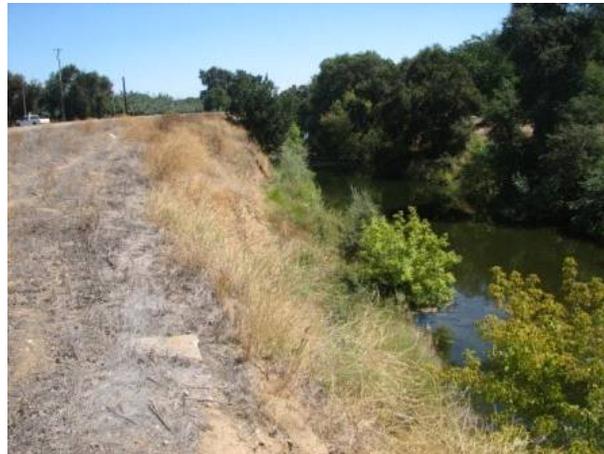
SJR2012_NA0017U15RM0.86_1.jpg

Levee Mile Report Line	7
Start Levee Mile	0.41
End Levee Mile	1.32
Location	Water Side
Category	Supplemental
Item	DWR Erosion Survey

Looking upstream

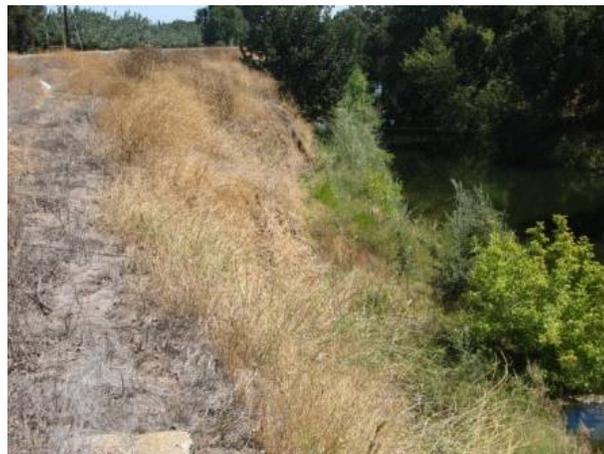
SJR2012_NA0017U15RM0.86_2.jpg

Levee Mile Report Line	7
Start Levee Mile	0.41
End Levee Mile	1.32
Location	Water Side
Category	Supplemental
Item	DWR Erosion Survey

Close view of the erosion. Note the dense vegetation and tree on site.

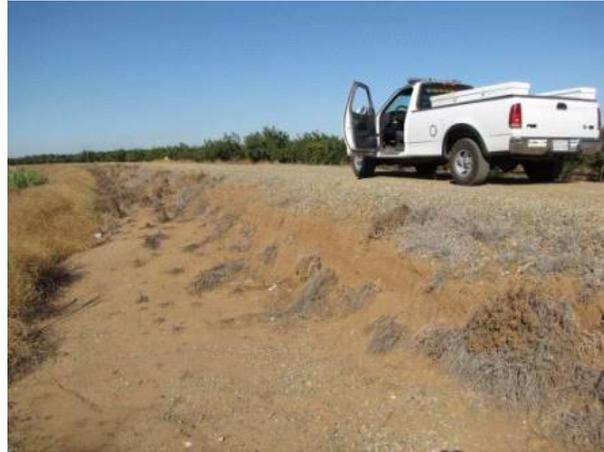
Levee Mile Report Line	9
Start Levee Mile	1.52
End Levee Mile	1.52
Location	Water Side
Category	Earthen Levee
Item	Erosion / Bank Caving
View of erosion of waterward levee slope looking upstream.	
pkazi_f_20120913_409.jpg

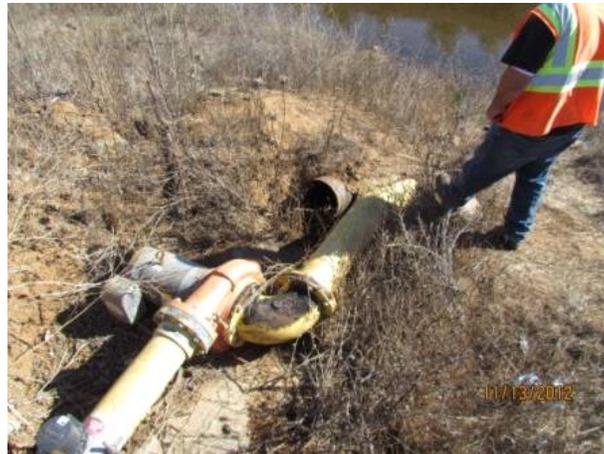
Levee Mile Report Line	14
Start Levee Mile	2.09
End Levee Mile	2.09
Location	Water Side
Category	Earthen Levee
Item	Encroachments
View of an open abandon pipe at the waterside toe of the levee looking upstream.	
pkazi_f_20121114_052.jpg

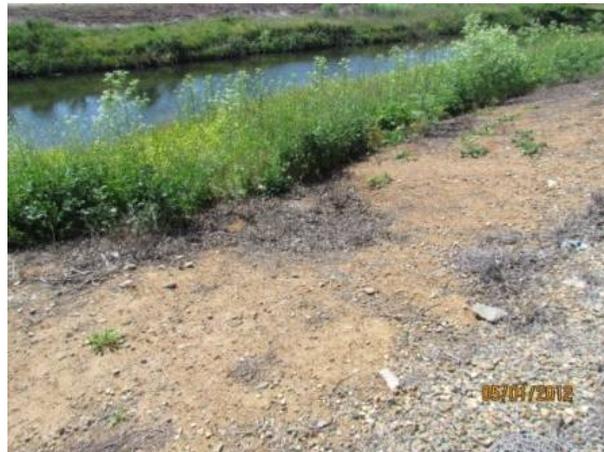
Levee Mile Report Line	15
Start Levee Mile	2.09
End Levee Mile	2.09
Location	Water Side
Category	Earthen Levee
Item	Slope Stability
Slope instability was found on the waterside toe of the levee looking downstream.	
pkazi_f_20120913_306.jpg

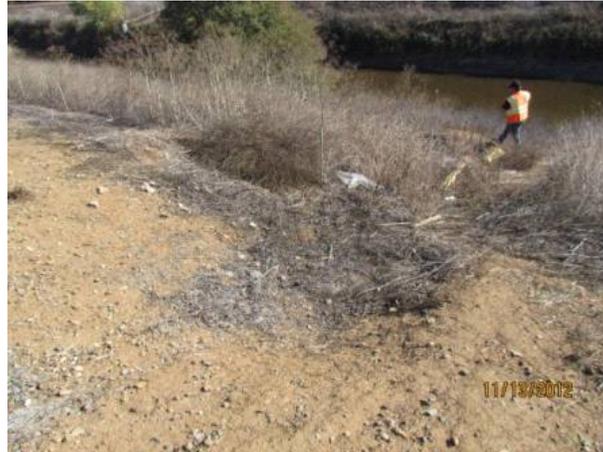
pkazi_f_20121114_053.jpg

Updated picture of the slope instability at the waterside slope of the levee looking upstream.

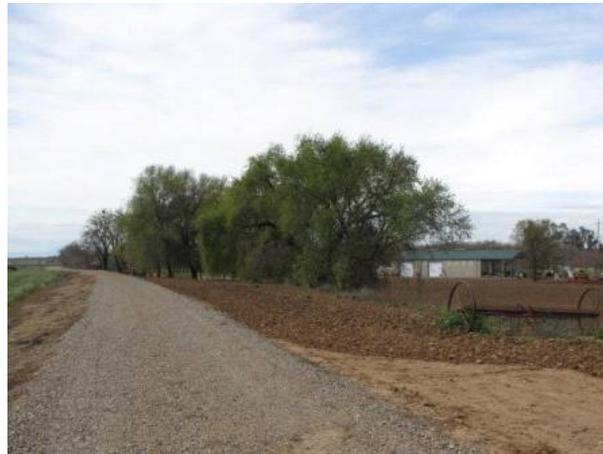
pkazi_f_20120913_320.jpg

Levee Mile Report Line	17
Start Levee Mile	2.42
End Levee Mile	2.57
Location	Land Side
Category	Earthen Levee
Item	Encroachments

View of the landward shoulder where a landowner has disced the levee looking downstream.
